CASAMICCIOLA - ITALY

Mass movement - Situation as of 27/11/2022

Grading - Detail map 03

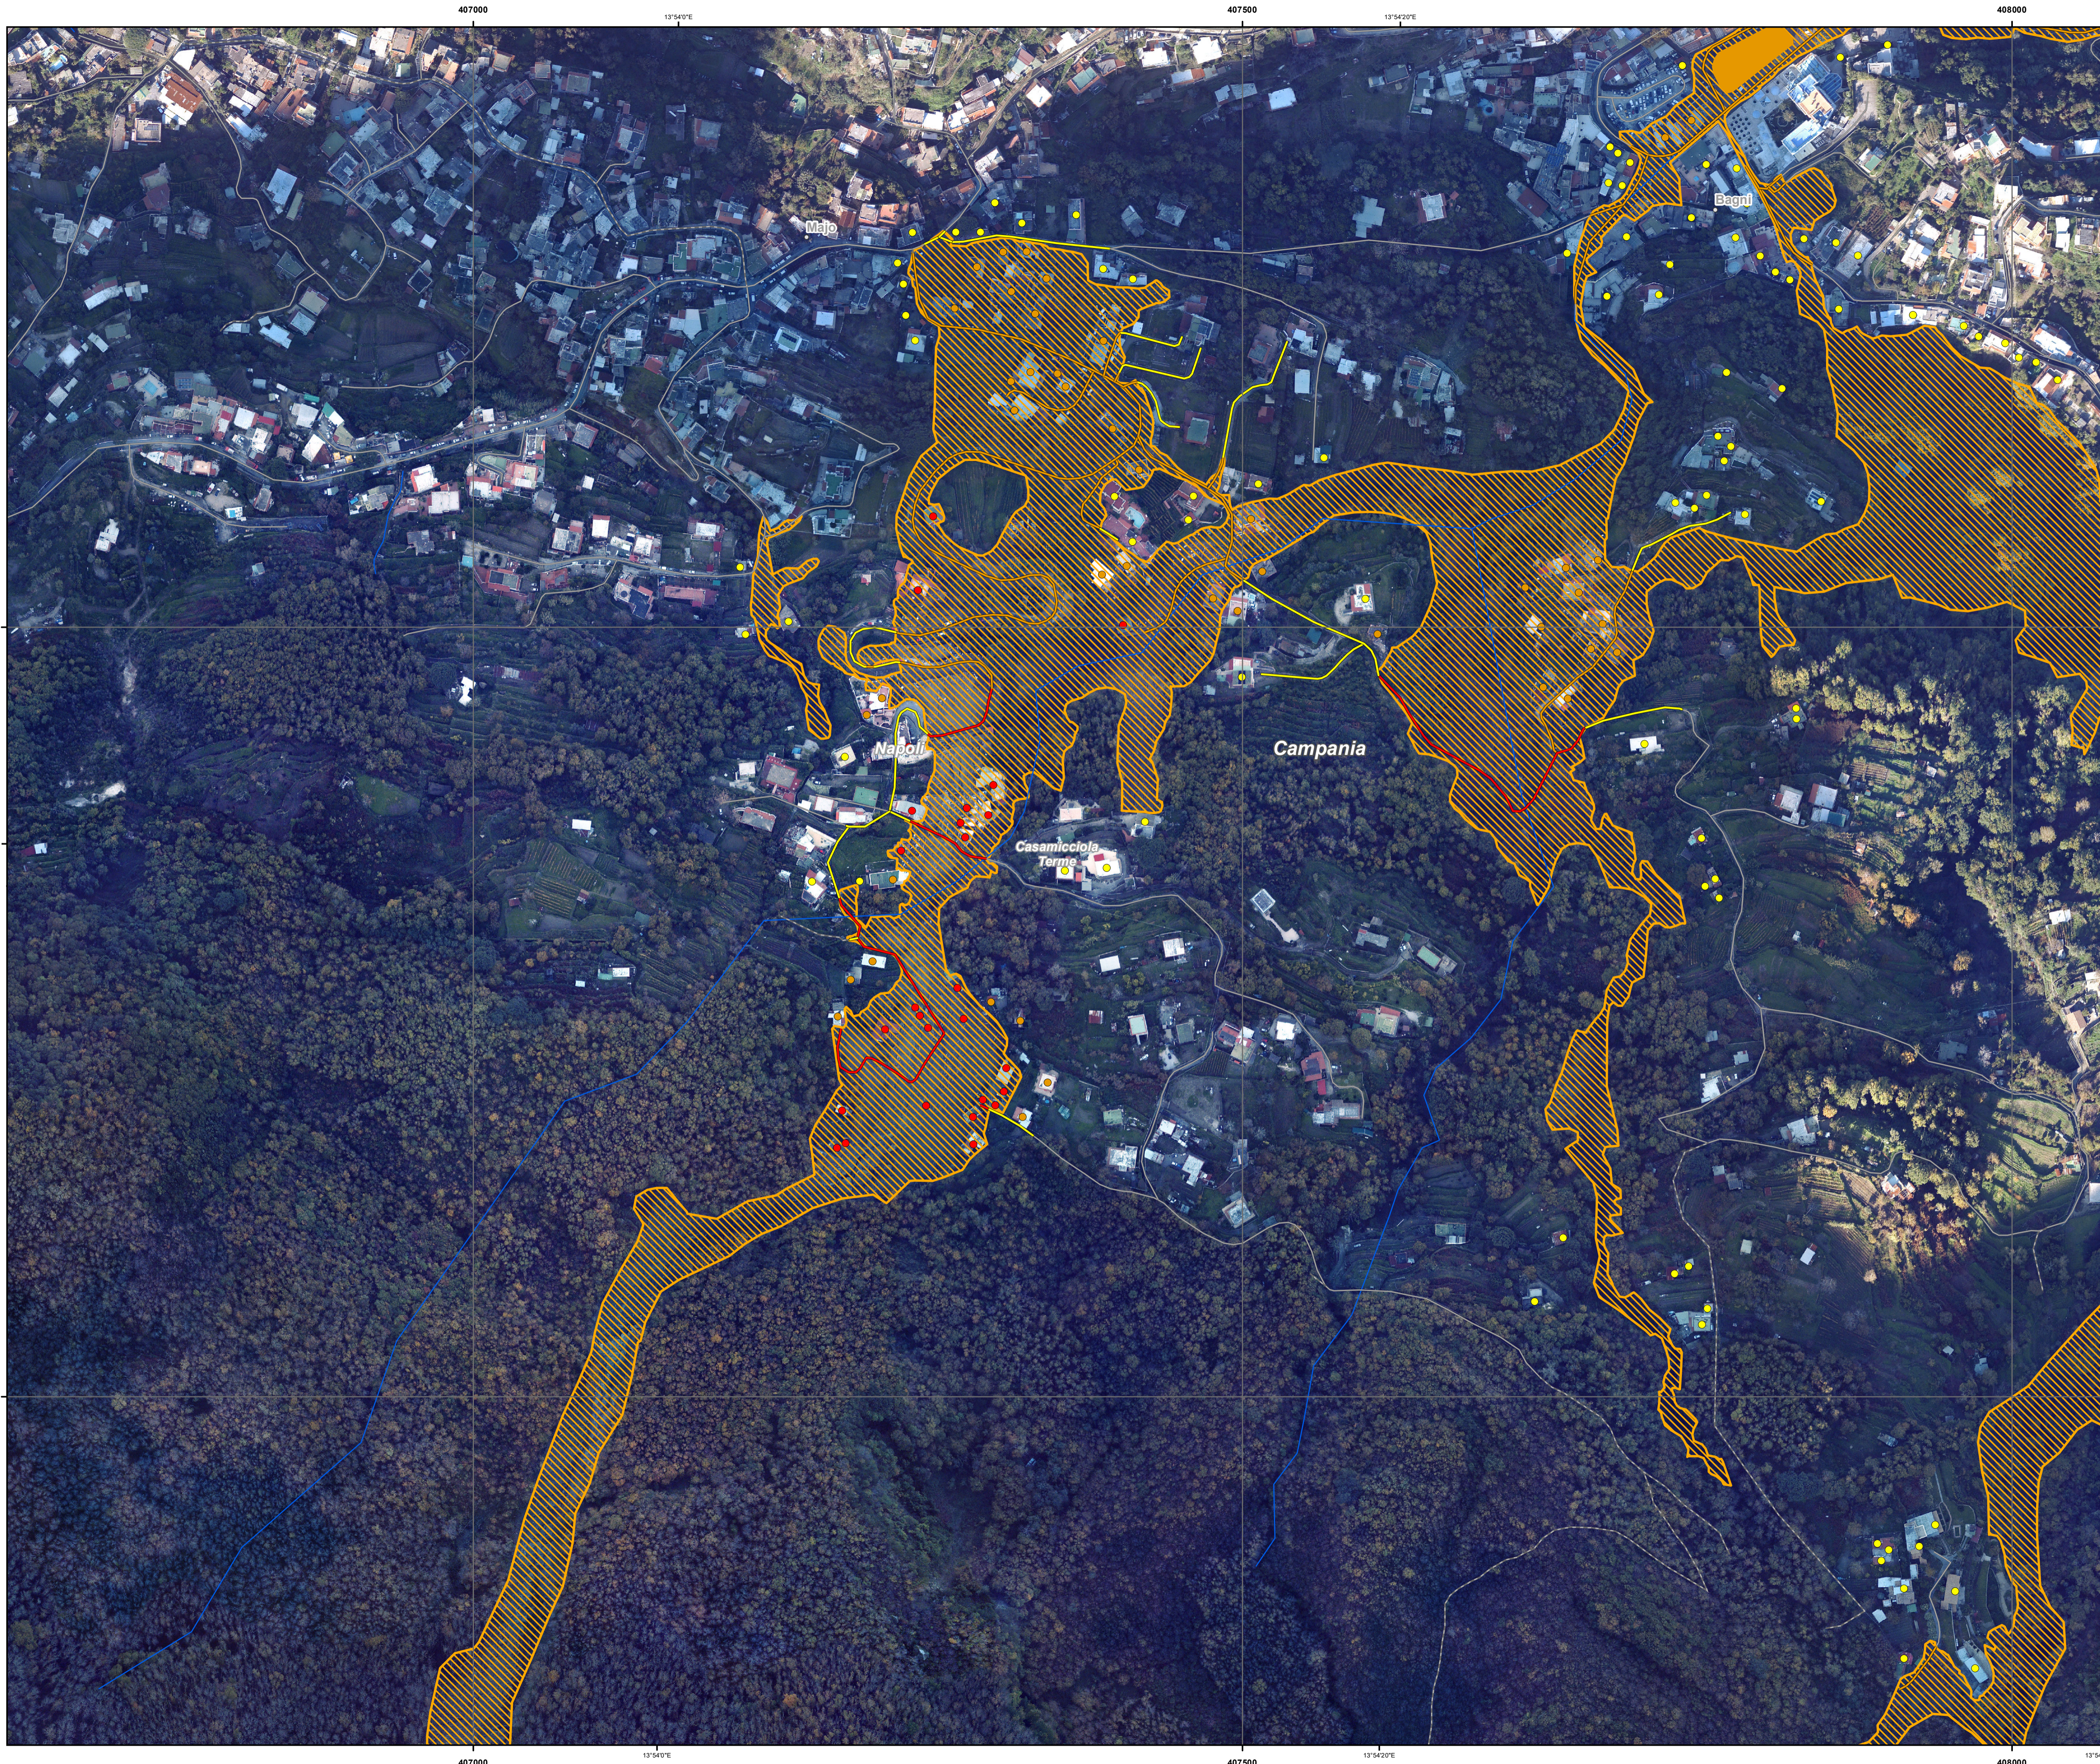
During the night between 25 and 26 November 2022, a cyclone centred over Italy brought heavy rains to central and southern Italy, particularly over the Campania region. The heavy rains triggered a huge mudflow on the mountainside near Casamiciola hamlet on the island of Ischia, just off the coast of Campania. At least ten houses were destroyed and several roads were interrupted by the landslide. The present map shows the landslide damage grade assessment in the area of Casamiciola (Italy). The thematic layer has been derived from post-event satellite image by means of visual interpretation. The scale of analysis is 1:10000. The estimated geometric accuracy (RMSE) is 2.5 m or better, from native positional accuracy of the background satellite image. The minimum mapping unit (MMU) is 2.5 sq m.
